CONNECTICUT RIVER BASIN
MONROE, NEW HAMPSHIRE

TYLER TREE FARM DAM
NH00325

PHASE I INSPECTION REPORT
NATIONAL DAM INSPECTION PROGRAM

JUNE 1979

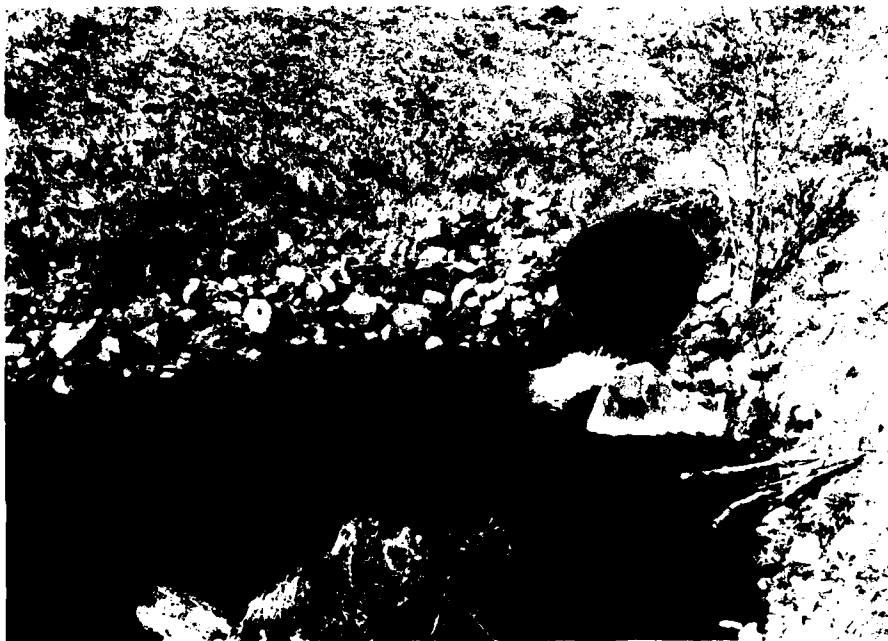
Figure 5 - View of 48" diameter discharge pipe. Note placed riprap at outlet.

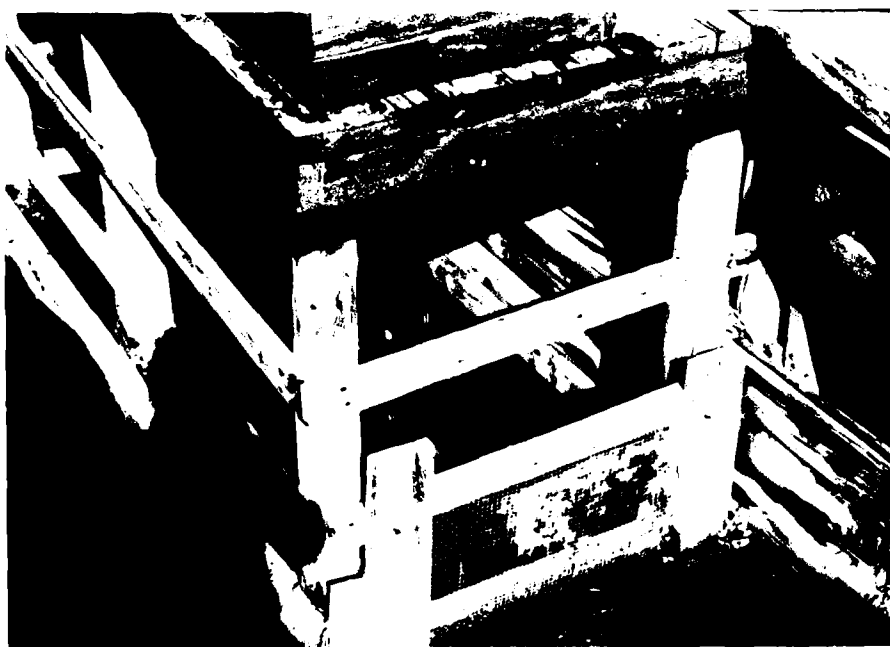
Figure 7 - View of the drop-inlet principal spillway.

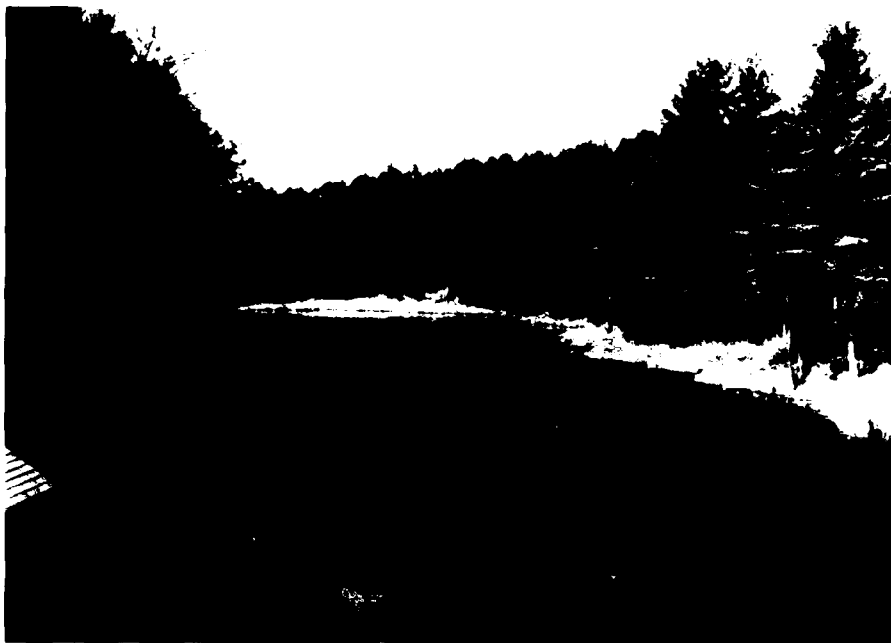
d. Reservoir Area. The watershed above the reservoir is rolling and partially wooded. No camps or other structures were noted on the shoreline of the reservoir. No visible evidence was noted of significant sedimentation in the reservoir. (See Appendix C - Figure 8.)

Figure 8 - Looking upstream into the reservoir.

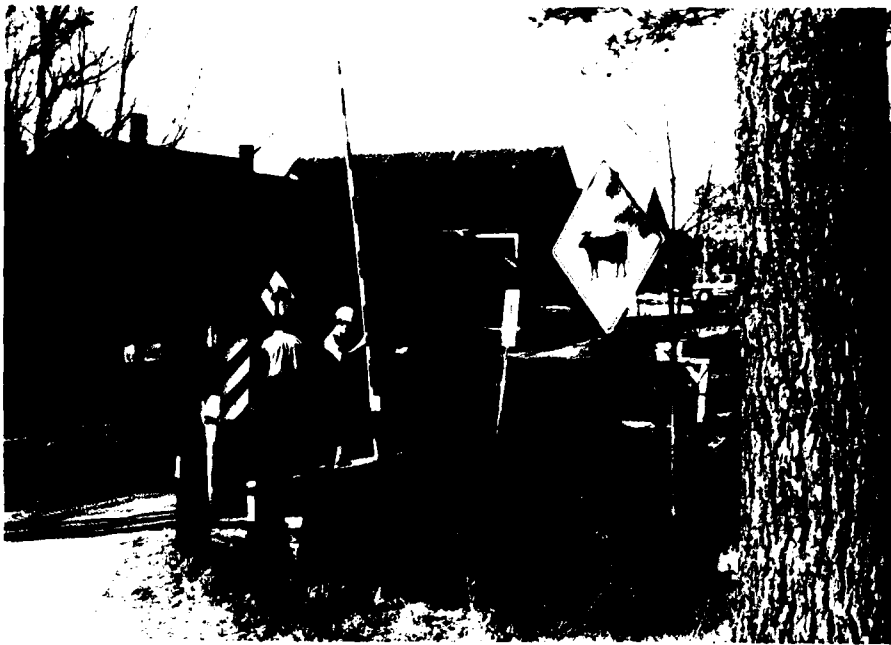
Figure 10 - Looking at State Route 135 located about one mile downstream of the dam.
